APPENDIX ONE: DATA DICTIONARY FOR DIGITAL MAPPING

APPENDIX TWO: AERIAL AND SATELLITE IMAGERY METADATA

APPENDIX THREE: ROCHES BEACH REFERENCE PHOTOS 2006

Shoreline Change at Roches Beach

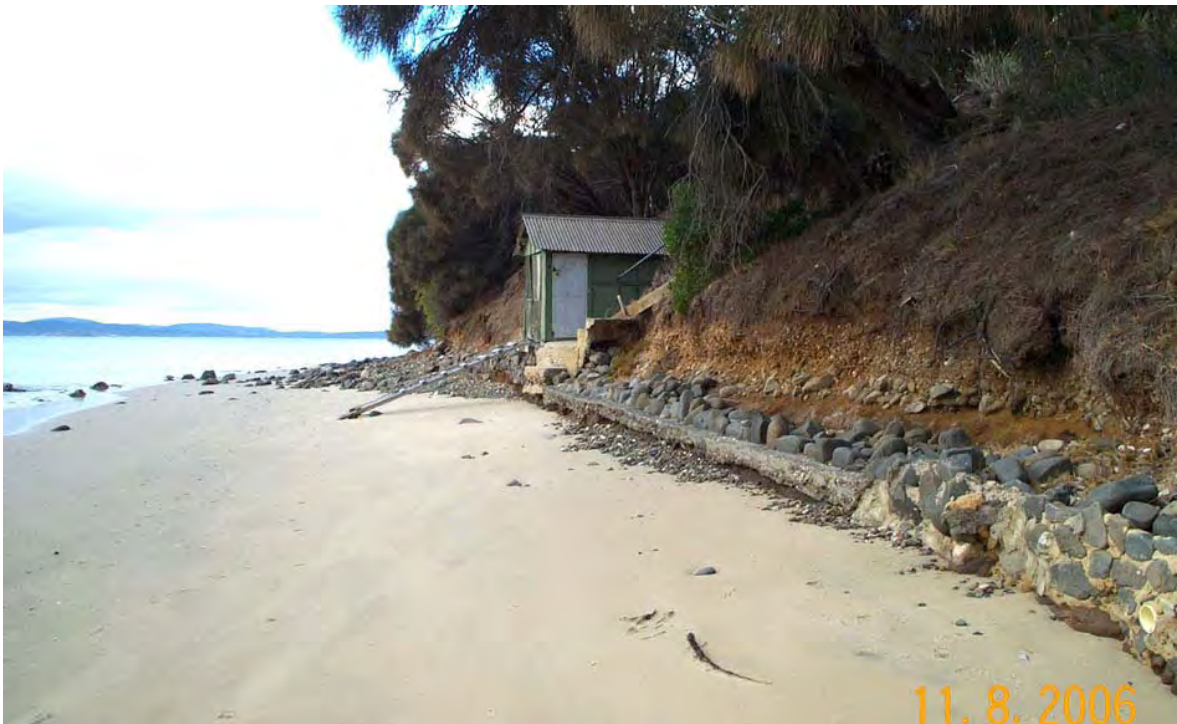
Figure 27: Photo RB2006_6 (Viewpoint 5). An old erosion scarp is evident in places behind this southern part of Roches Beach, eroded into (partly) colluvial soil over weathered bedrock. The artificial wall seen here is evidently ineffective in stopping erosion, however only a small amount of net erosion has occurred here over the last 50 years, insufficient to be detectable as net recession on air photos.

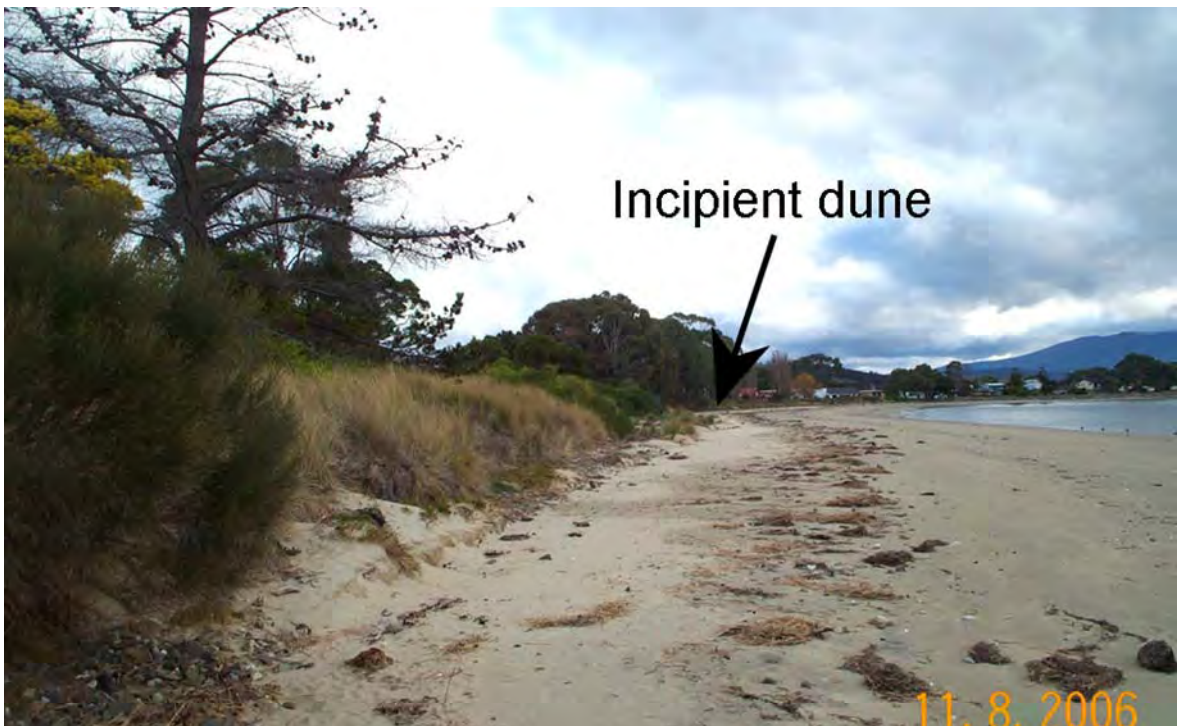
Figure 28: Photo RB2006_8 (Viewpoint 7). The shoreline in this short section of southern Roches Beach has accreted in recent times, as indicated by the small incipient dune present in front of the larger established foredune on this part of the beach; however this section of the shore has shown no detectable net change between 1957 and 2005. Only a few southern and northern sections of Roches Beach show evidence of sand accretion at the present.

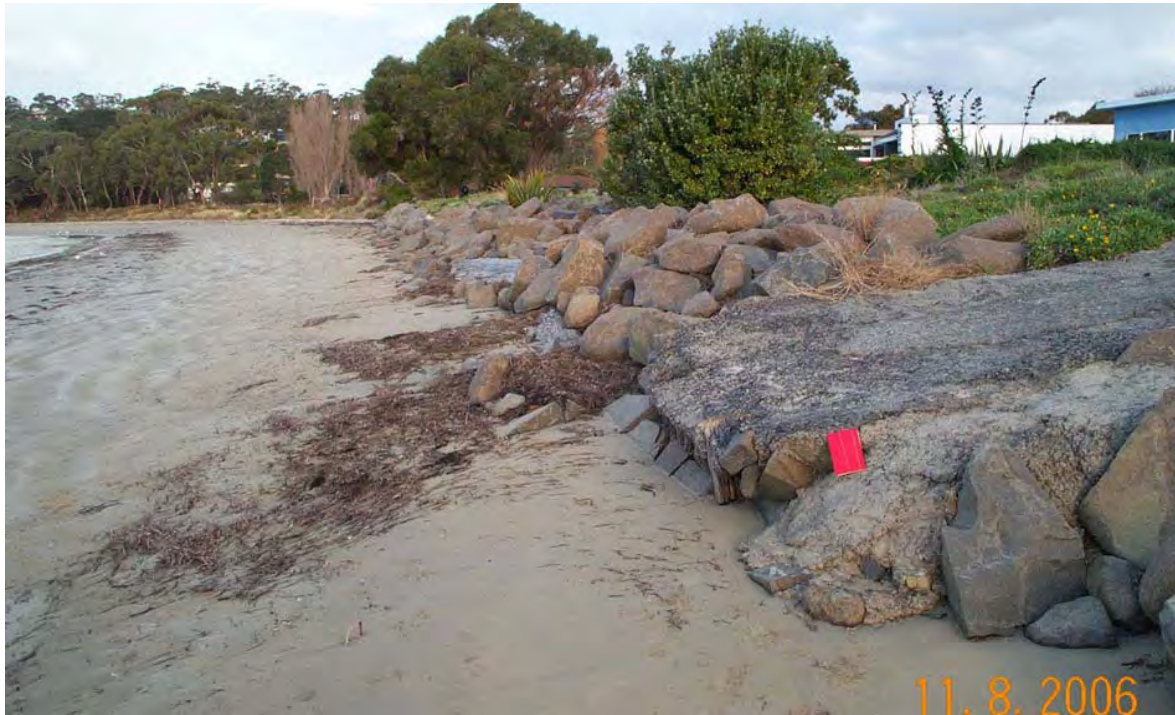
Figure 29: Photo RB2006_20 (Viewpoint 13). This view shows a concrete boat ramp in the boulder wall along part of the southern area of Roches Beach. Lowering of the beach surface below the lip of the ramp is probably a result of recent stormy conditions. The surface will probably grow (accrete) upwards during long calm weather periods, however it is likely that some degree of net lowering of the beach surface has occurred since the boulder wall was constructed in 1988, due to increased wave reflection off the hard wall. Red notebook is 180mm high.

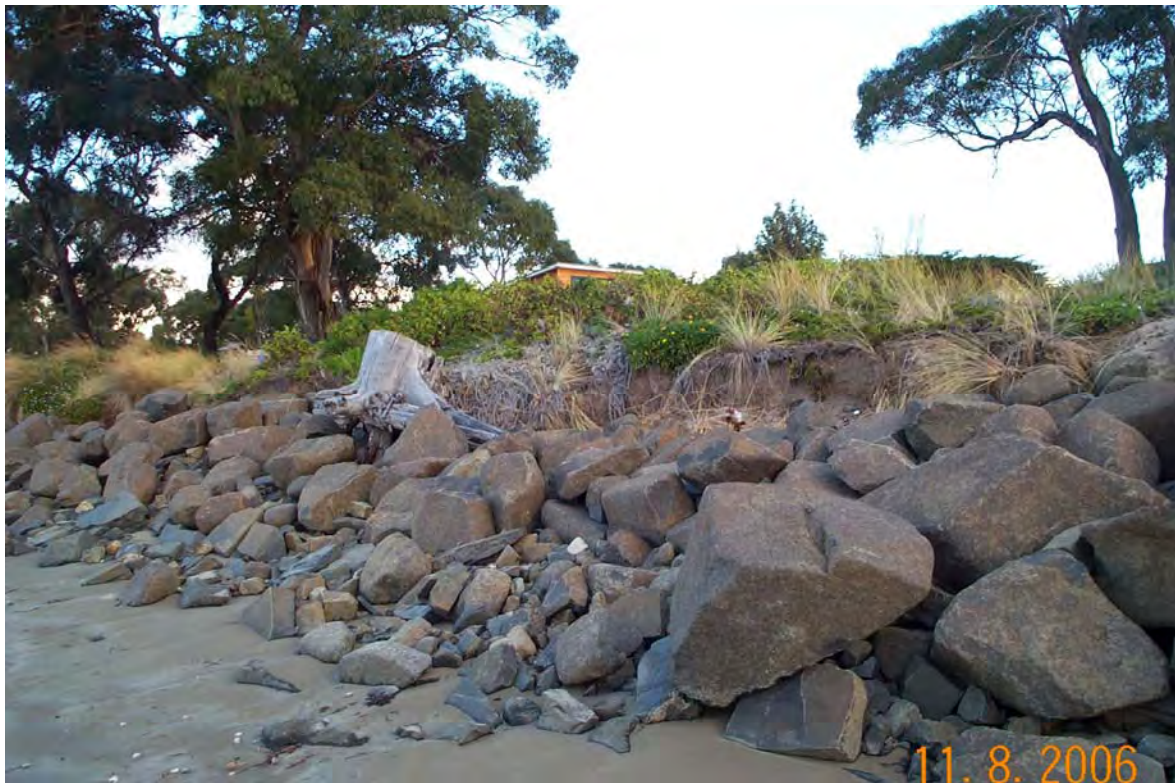
Figure 30: Photo RB2006_26 (Viewpoint 16). This view of the boulder wall (revetment) shows foredune erosion above and behind a section of the wall, indicating that storm waves have begun to overtop and erode behind the boulder wall in this area.

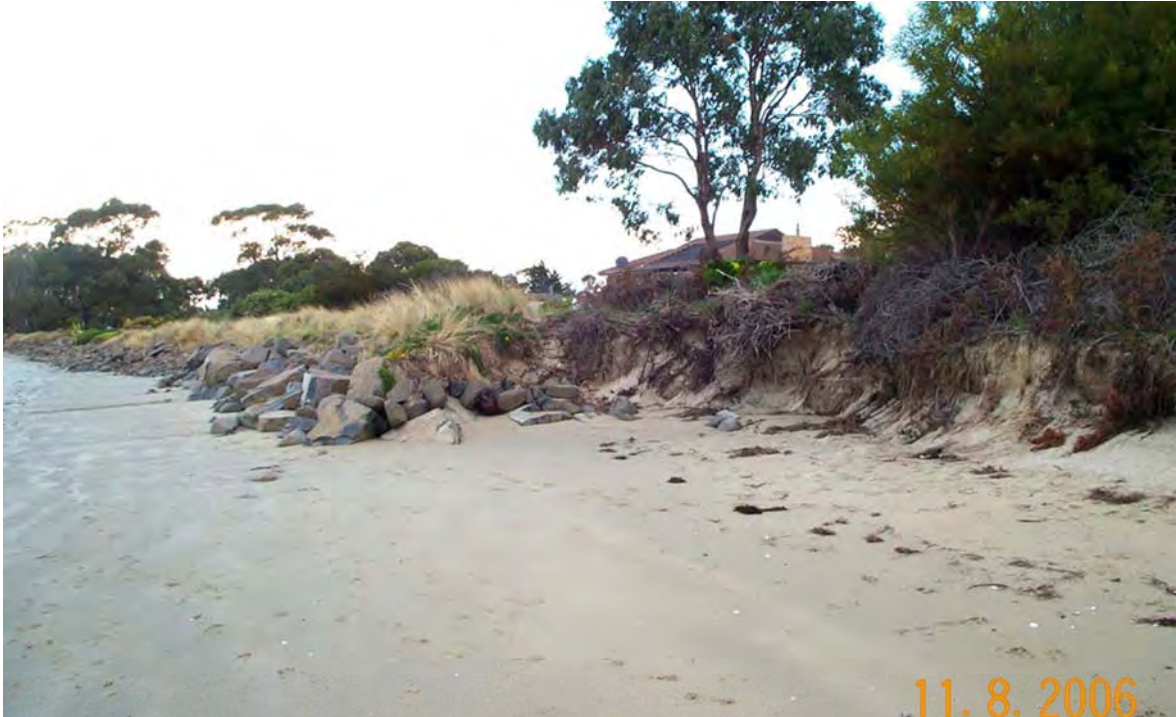
Figure 31: Photo RB2006_28 (Viewpoint 17). View southwards from the northern end of the boulder wall along part of the southern area of Roches Beach. This photo shows a shoreline (dune – front) net recession of about 5 metres at this point since the boulder wall was constructed during 1988.

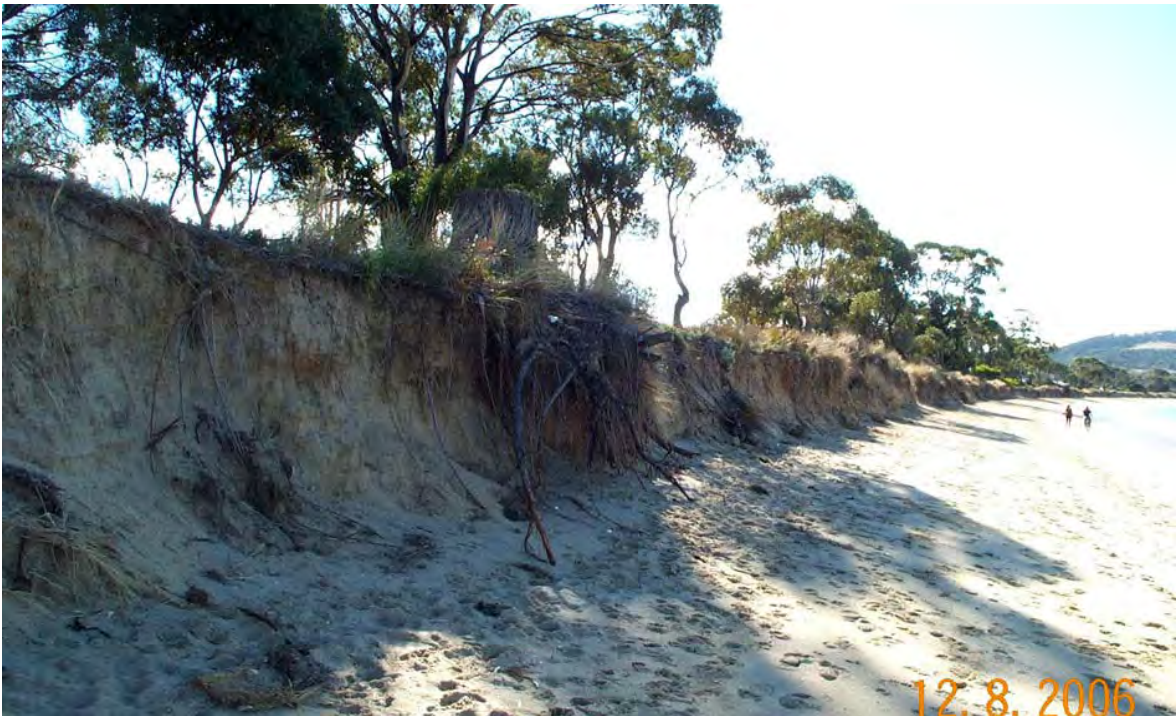
Figure 32: Photo RB2006_49 (Viewpoint 26). View north along Roches Beach erosion scarp, several hundred metres north of the canal. The sawn stump of a large eucalypt tree whose roots became exposed by erosion in the period 2001 – 2006 is visible. This view is in the area referred to as recession zone RZ3 in this report.

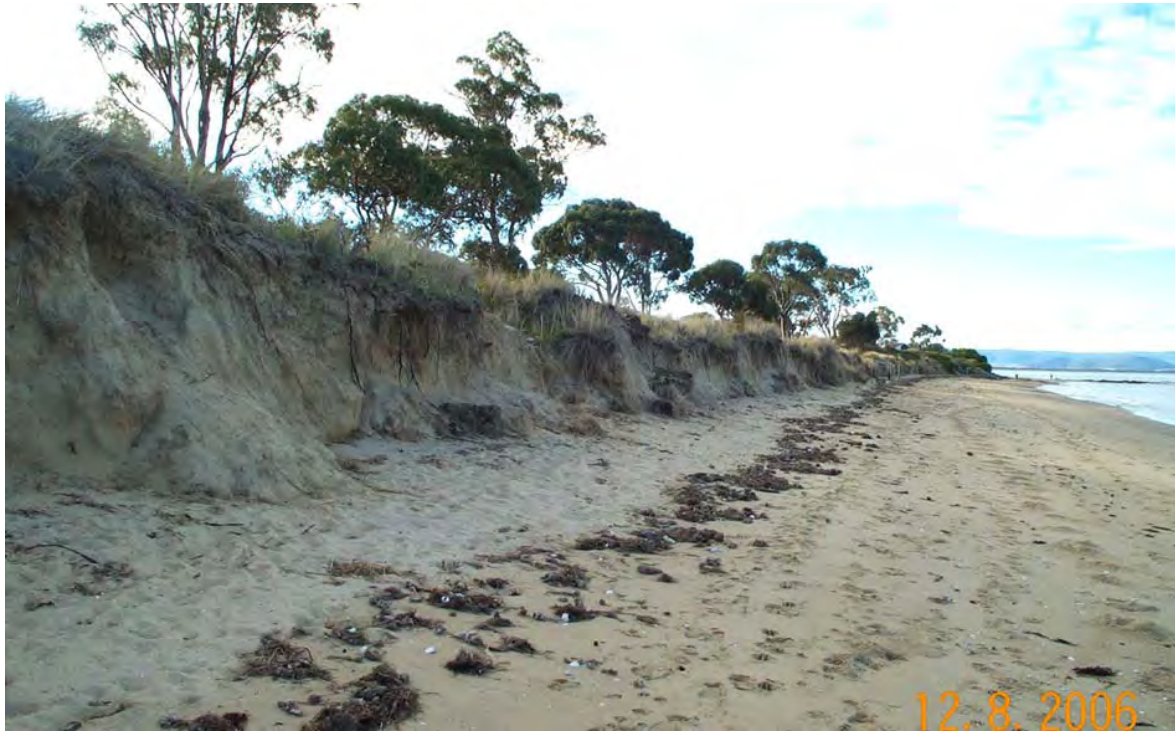
Figure 33: Photo RB2006_71 (viewpoint 37). View north along the large active erosion scarp in the northerly part of Roches beach. This view looks along the area referred to as recession zone RZ5 in this report.

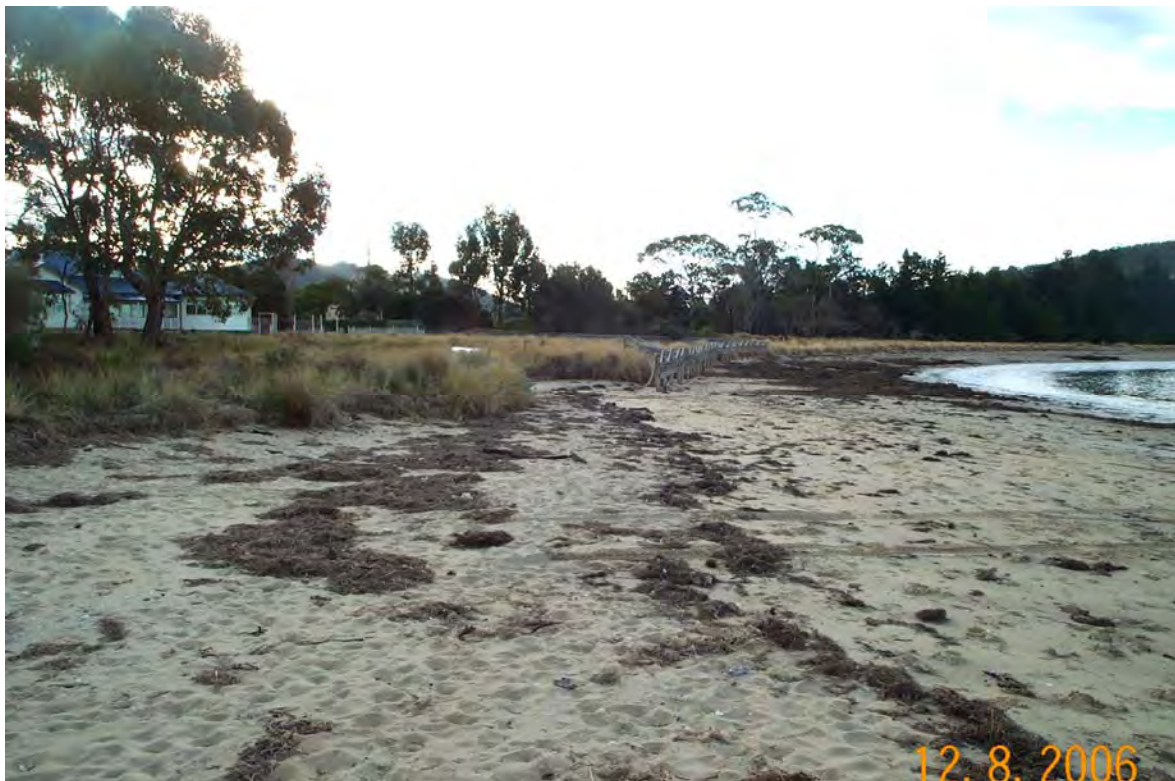
Figure 34: Photo RB2006_81 (viewpoint 42). View north showing Accretion Zone AZ1, immediately north of the small rocky point (Bambra Reef) at the north end of the main part of Roches Beach. This is one area where net detectable shoreline accretion has occurred at Roches Beach between 1957 and 2005. It is unlikely that the visible fence has been a major factor in the accretion, which is probably due to the location of this area on the down-drift (north) side of Bambra Reef.

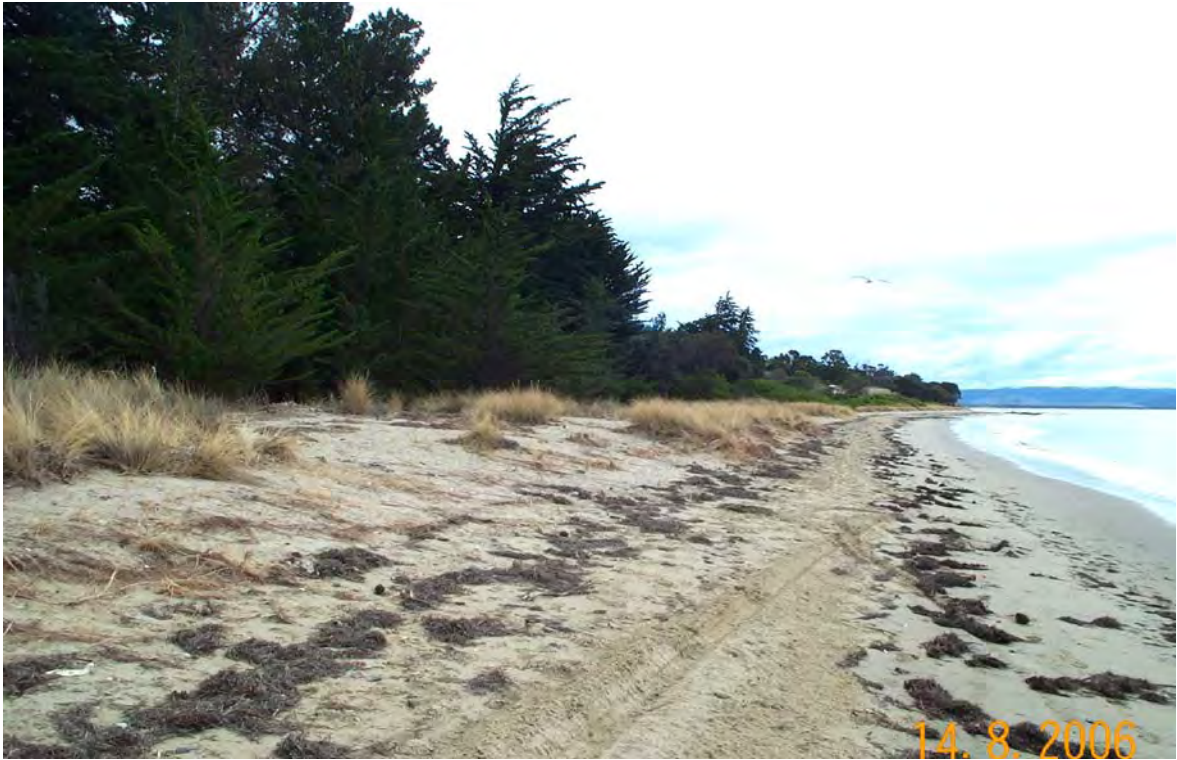
Figure 35: Photo RB2006_86 (viewpoint 44). View north showing part of Accretion Zone AZ2 with low incipient foredune development. This is an area where net detectable shoreline accretion has occurred at Roches Beach between 1957 and 2005.

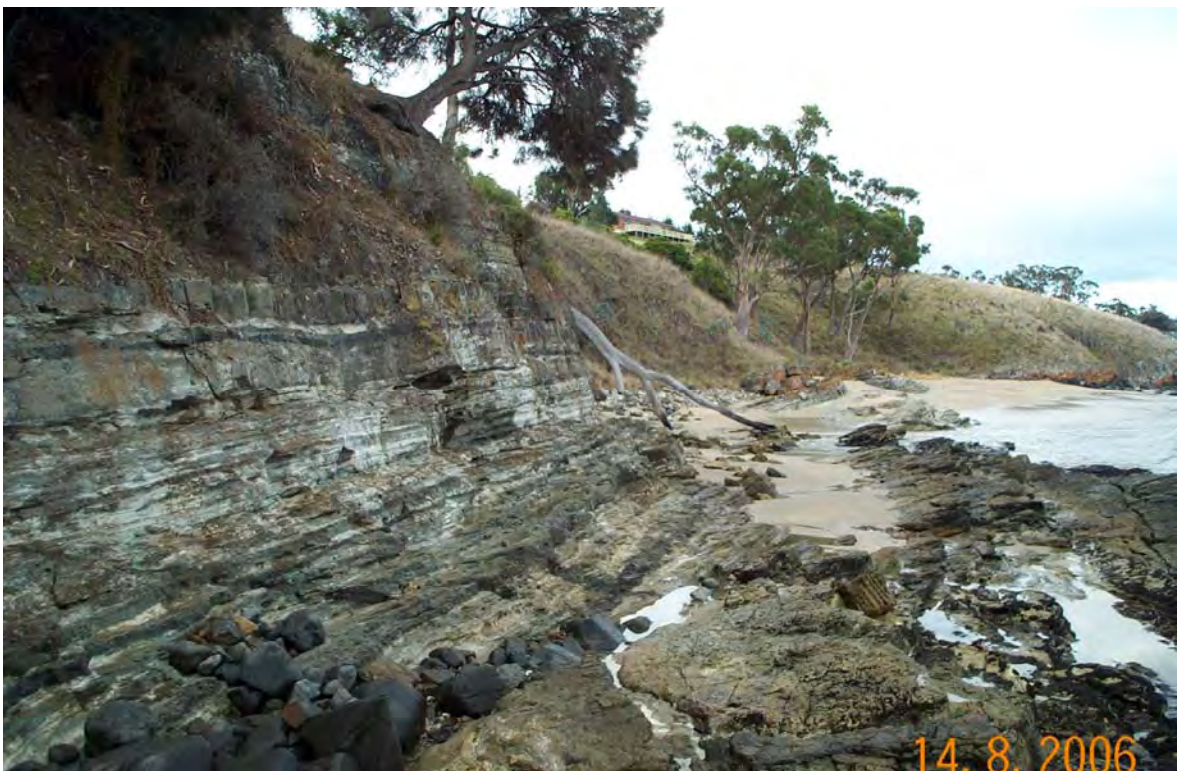
Figure 36: Photo RB2006_103 (viewpoint 53). View north along part of the northernmost end of Roches Beach, where the beach is backed by a rising bedrock slope with little dune development. There is little potential for shoreline recession here, although beach lowering and loss may result from sea level rise.
